Mitsubishi Turbocharger

Quality Bulletin Mitsubishi Pajero

49135-02110

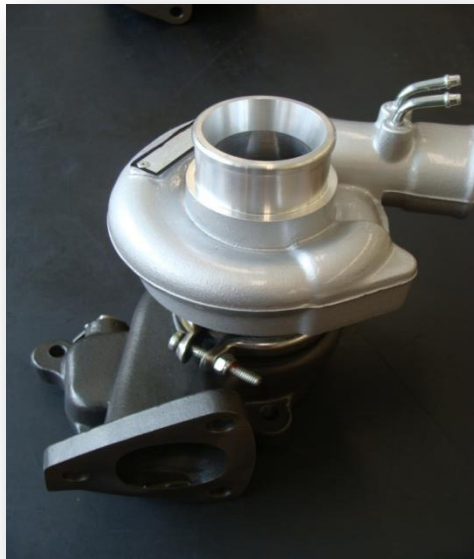
On the left you can see that Turbo seems to look very nice. But after inspecting it, it seems it is sprayed to camouflage possible imperfections in the casting. MHI Turbo's will never be sprayed or painted.

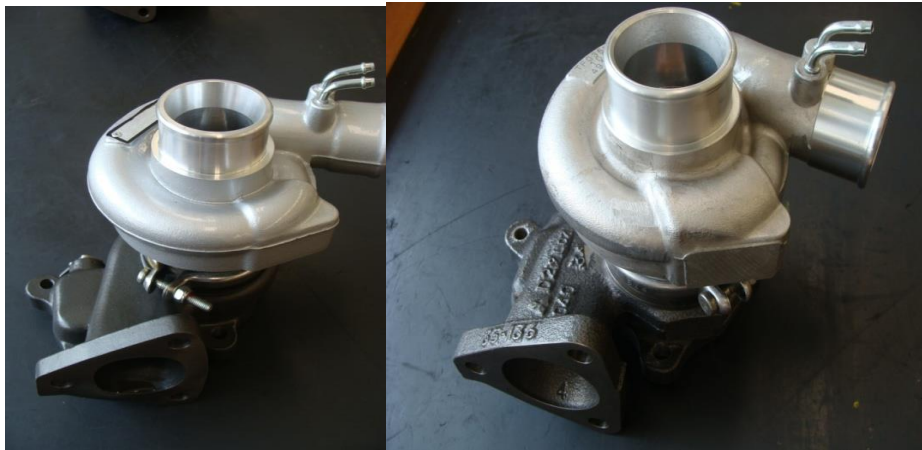
In the pictures below you can see the Chinese part on the left and the MHI on the right. Here you can see clearly that the air outlet of the Turbo is machined by MHI to reduce leakage. The replacement part outlet is not even rounded and has casting lines on it. This will never be a secure fit without leakages.

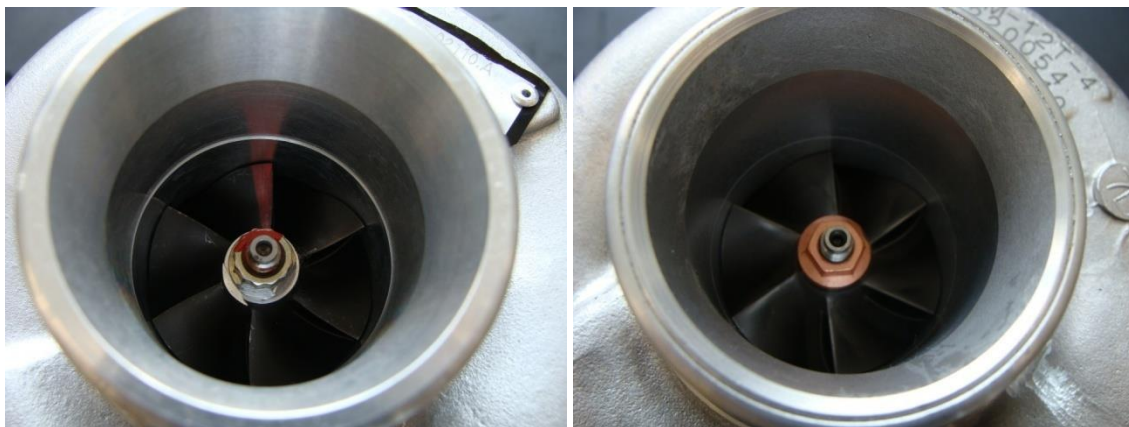
Just as the last replacement part Turbo we tested the compressor wheel of this Turbo is also manually balanced. It is of low quality, with burrs and out of specification. When running this wheel, it will cause a lot of vibration and noise.

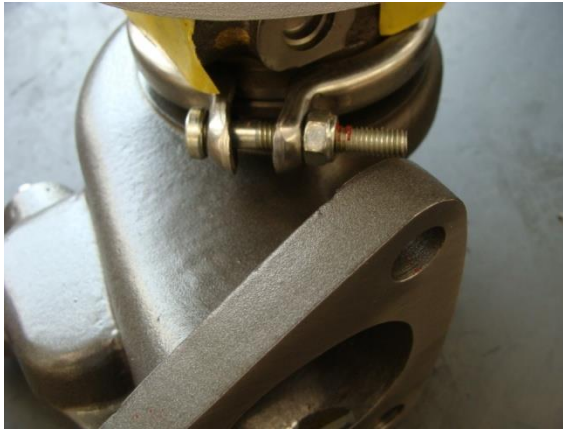
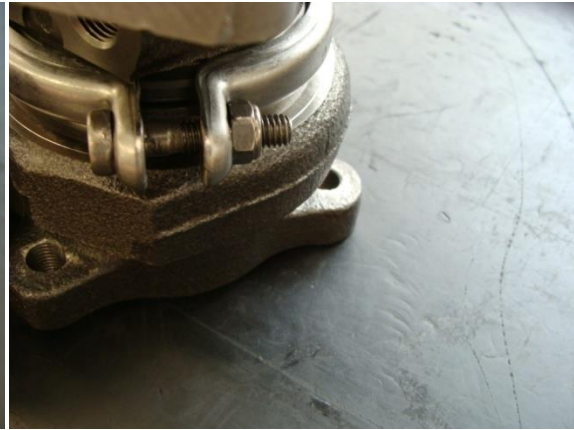
The replacement part Turbo has the wrong coupling and is also assembled in the wrong position; this can lead to difficulties when fitting the Turbo. The V-coupling and bolt are weak and together with the wrong assembly it has a big change of leaking.

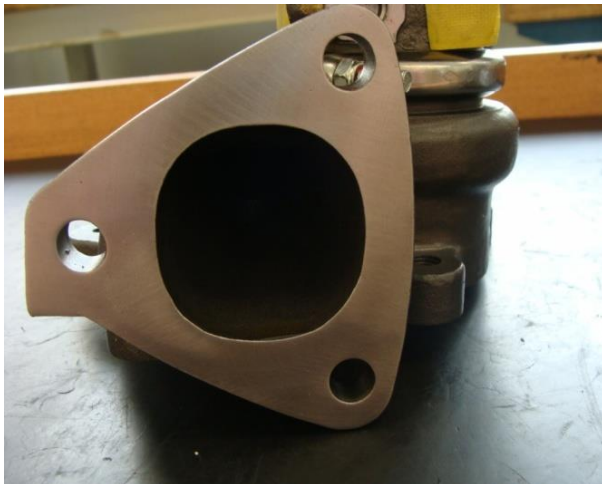
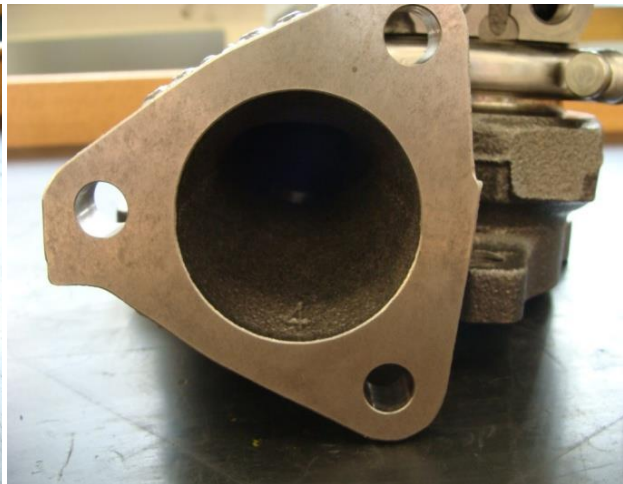
Gas inlet of the replacement part Turbo is not round and can cause gas leakage and turbulence.

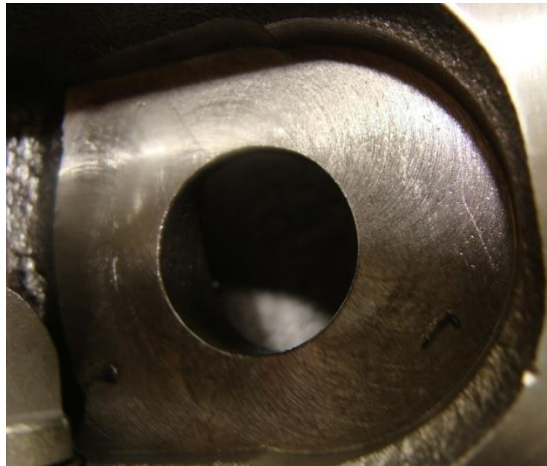
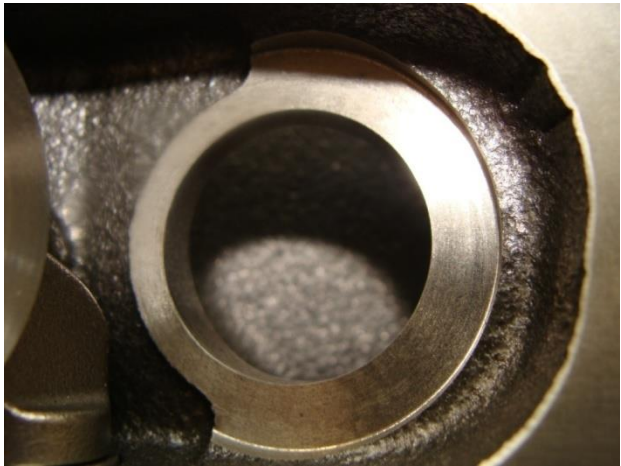
As you can see the complete design of the Turbo is different. This can also be seen at the waste gate diameter. The replacement part has a significantly smaller hole that could cause boost creep at full throttle.

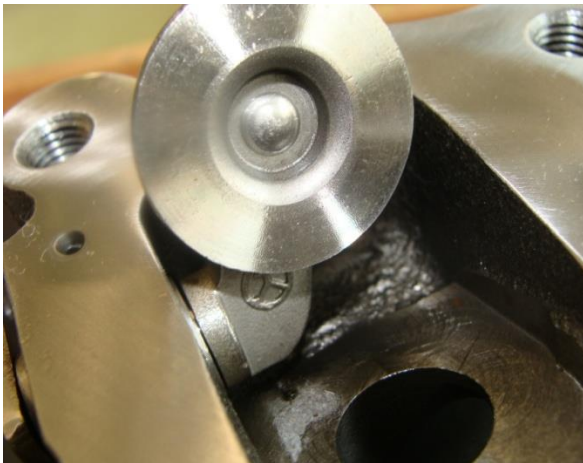
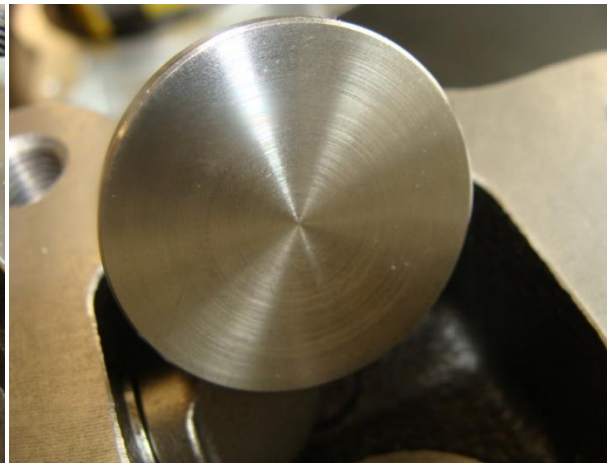
The waste gate valve is of poor quality and will deform and cause leakage. You can clearly see the differences in design and material.

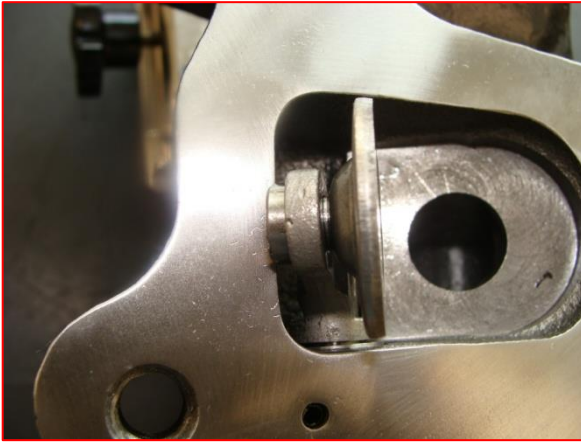
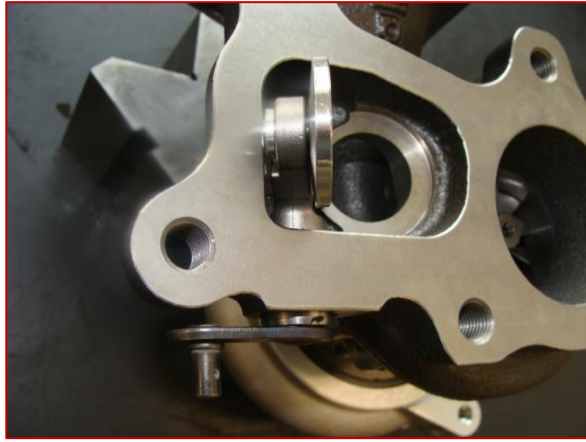
The faulty design of the valve will cause noise and will not function as it should.

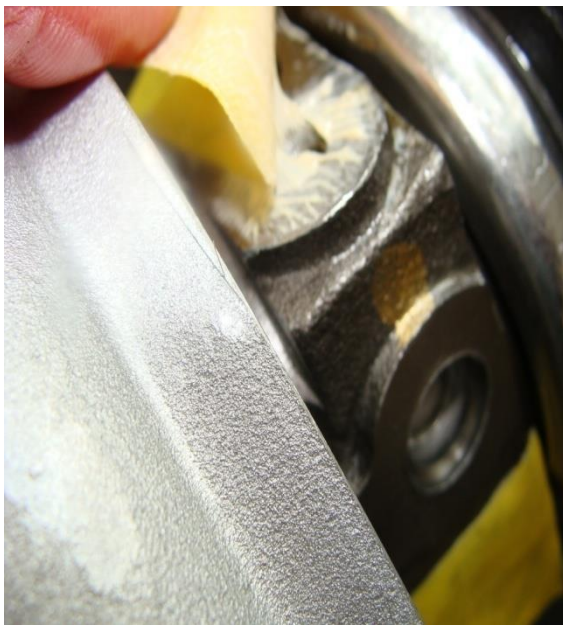
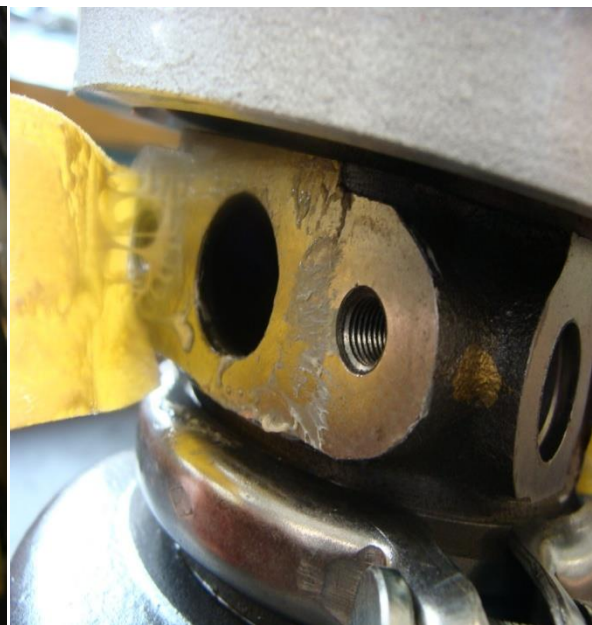
To avoid rust the replacement parts used scotch tape to close the oil outlet holes. The material of the bearing housing is also of low quality. The scotch tape residue is difficult to remove and could cause leakage after fitting.

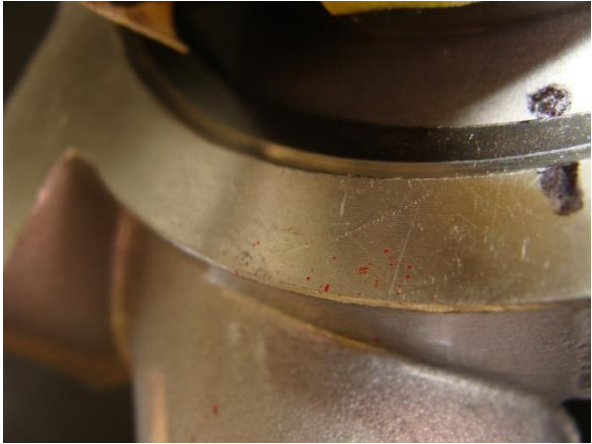
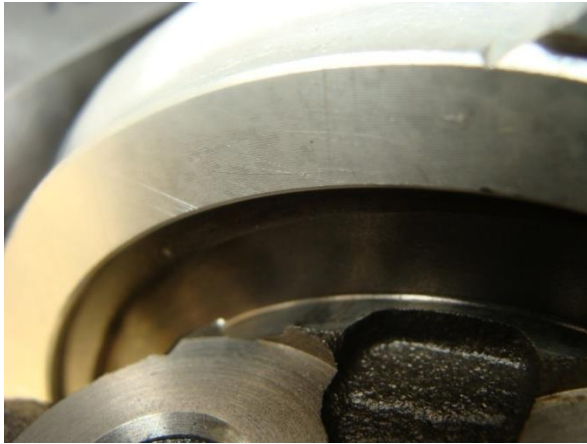
The snap ring is not in the correct position and could cause rotation of the Turbo sides.

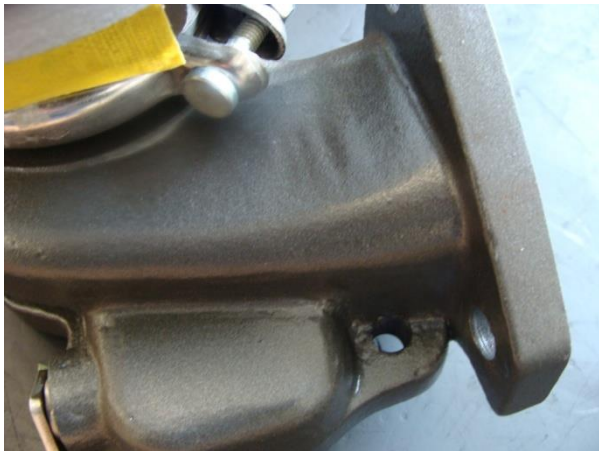
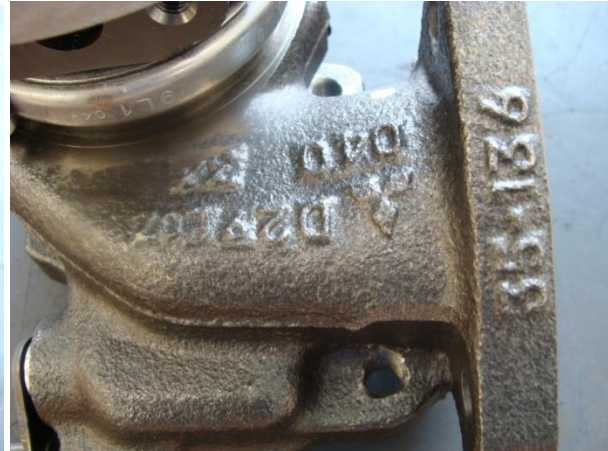
At the beginning of this message we started with the overall appearance of the replacement part Turbo. This appearance seems to be sprayed on and only to cover up low quality casting and possible defects. Also the wall thickness of the replacement part is not good and less than 2 mm on important areas.

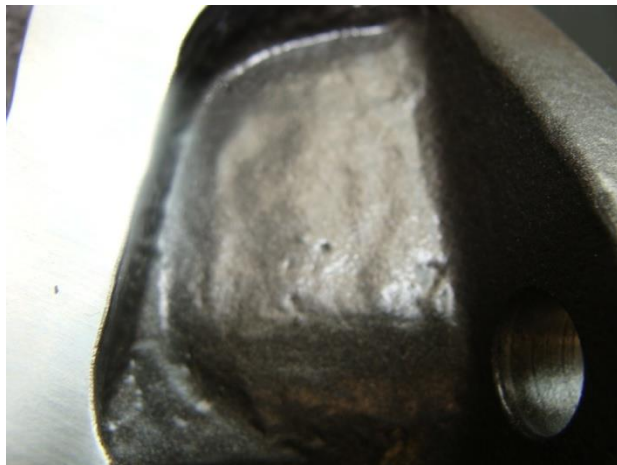
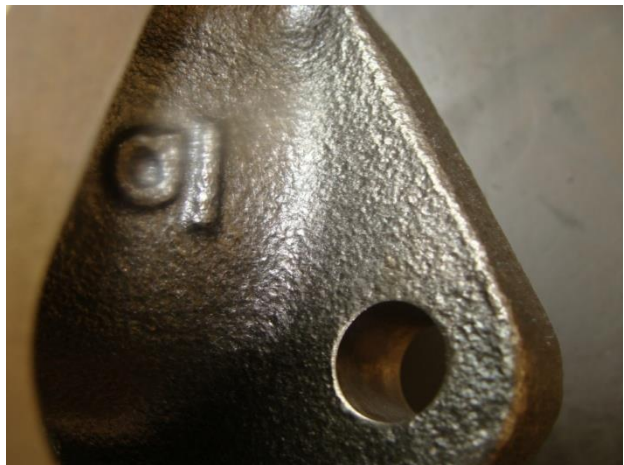
In the picture below you can clearly see the thick layer of perhaps paint to mask the very low quality cast iron.
